# Reaction Control System Thruster Cracking Consultation: NASA Engineering and Safety Center (NESC) Materials Super Problem Resolution Team (SPRT) Findings

Rebecca A. MacKay  
Glenn Research Center, Cleveland, Ohio

The shuttle orbiter's reaction control system (RCS) primary thruster serial number (S/N) 120 was found to contain cracks in the counter bores and relief radius after a chamber repair and rejuvenation was performed in April 2004. Relief radius cracking had been observed in the 1970s and 1980s in seven thrusters prior to flight; however, counter bore cracking had never been seen previously in RCS thrusters. Members of the Materials Super Problem Resolution Team (SPRT) of the NASA Engineering and Safety Center (NESC) conducted a detailed review of the relevant literature and of the documentation from the previous RCS thruster failure analyses of the 1980s. It was concluded from the review that the previous failure analyses lacked sufficient documentation to support the conclusions that stress corrosion cracking or hot-salt cracking was the root cause of the thruster cracking and lacked reliable inspection controls to prevent cracked thrusters from entering the fleet. The

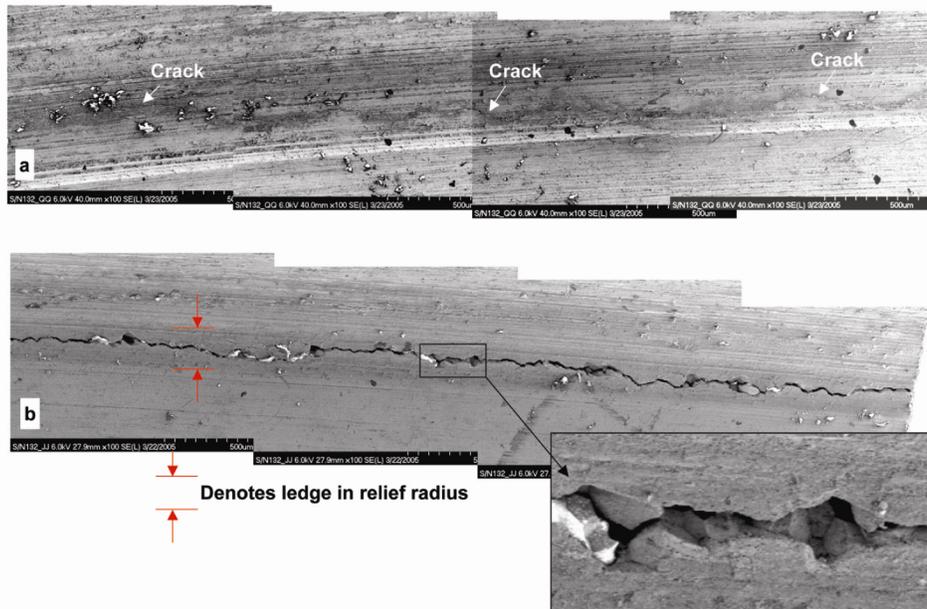
Figure 53.—Portions of S/N 132 relief radius from two different sections that show a range of tightness at the crack mouth. (a) Section QQ and (b) section JJ. Inset clearly shows intergranular cracking.

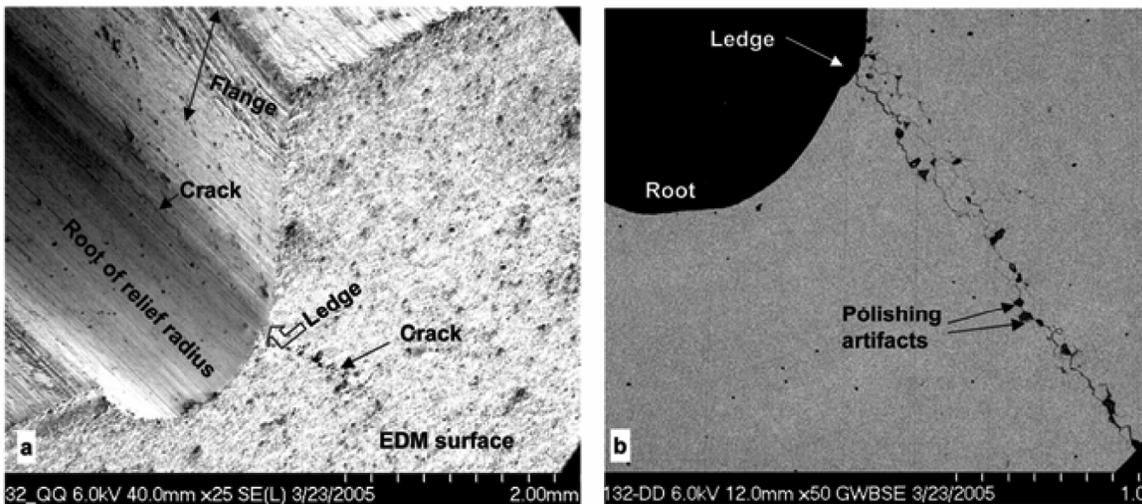
Figure 54.—Many of the relief radius cracks were initiated along a ledge in the relief radius adjacent to the injector flange. (a) Section QQ after electrodischarge machining. (b) Section DD after metallographic polishing. Polishing artifacts are present from grain pullout during metallographic preparation.

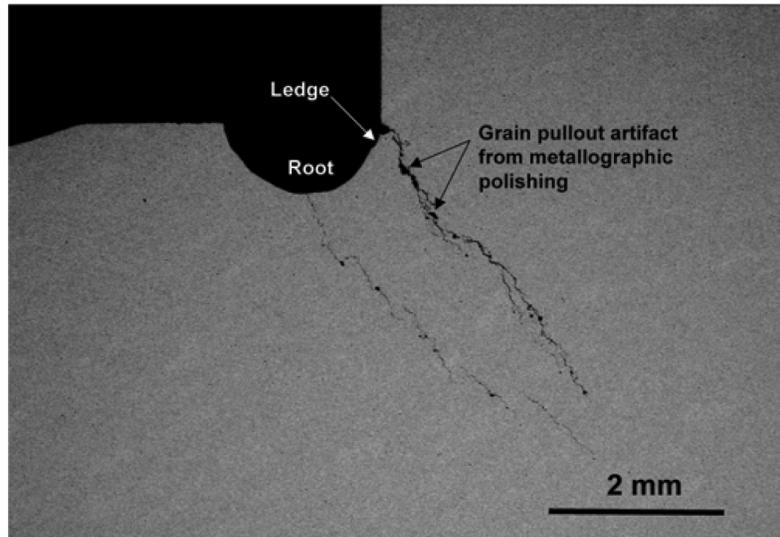
Figure 55.—Multiple cracks were observed in some polished sections. In section KK, a crack is observed to initiate along the ledge in the relief radius adjacent to the injector flange and at the base of the root of the relief radius. Polishing artifacts are present from grain pullout during metallographic preparation.

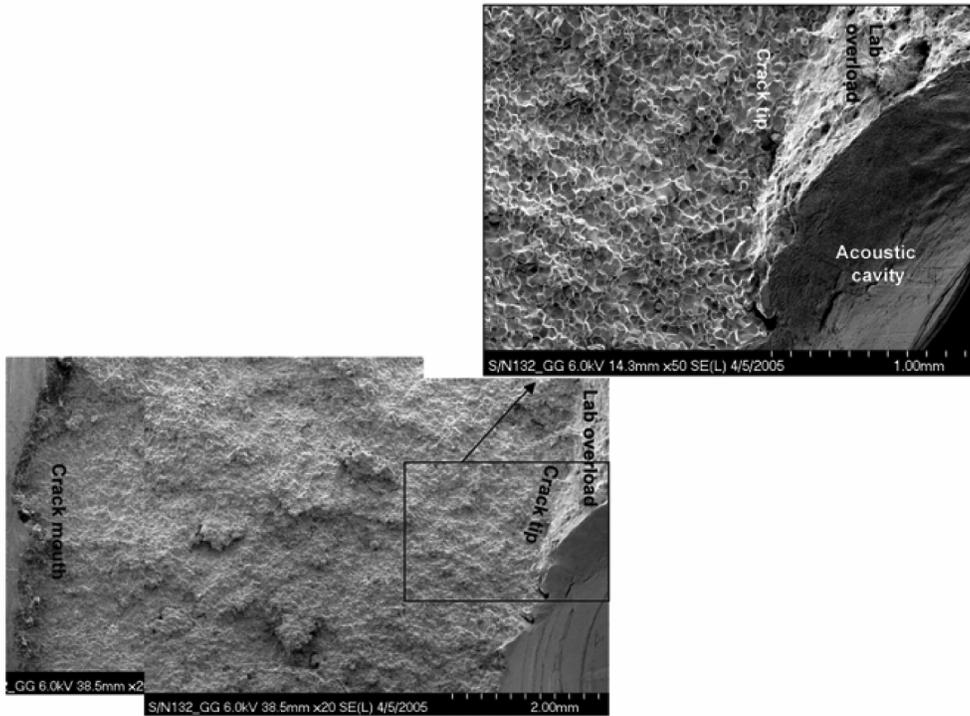
Figure 59.—Fractography confirms that the crack surface was entirely intergranular in S/N 132 with no change in crack mode from the mouth to the tip of the crack.

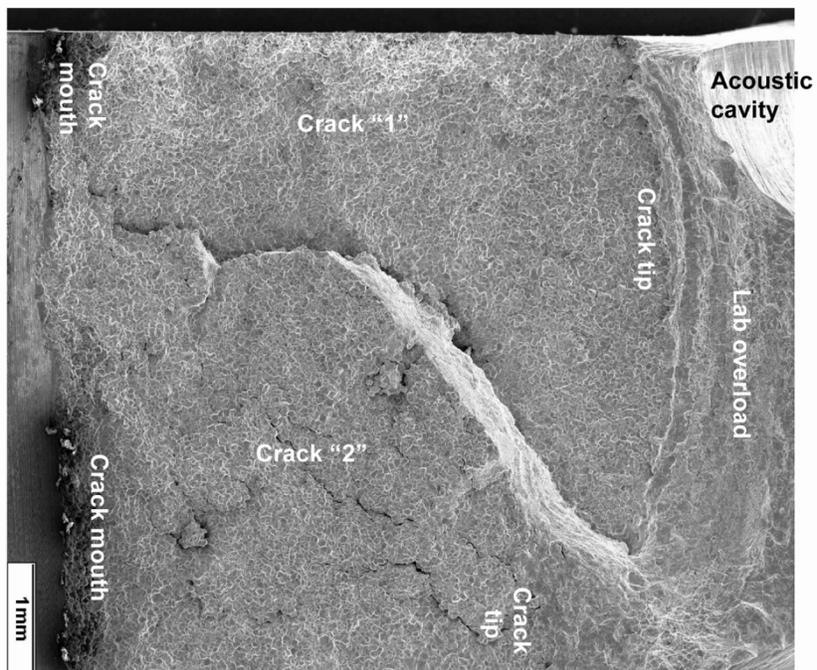
Figure 60.—Multiple cracks that initiated separately on the relief radius did not always connect subsurface to form a single crack front. Cracks are at slightly different elevations and are separated by a ductile ledge that formed during lab opening. Section II is shown for S/N 132.
